## ASOS MODIFICATION NOTE 68 (for Electronics Technicians)

SUBJECT : Installing Visibility Firmware Version 040

PURPOSE : Eliminate the visibility sensor heater diagnostic errors

EQUIPMENT : Automated Surface Observing System (ASOS) Visibility Sensor  
AFFECTED (AVIS)

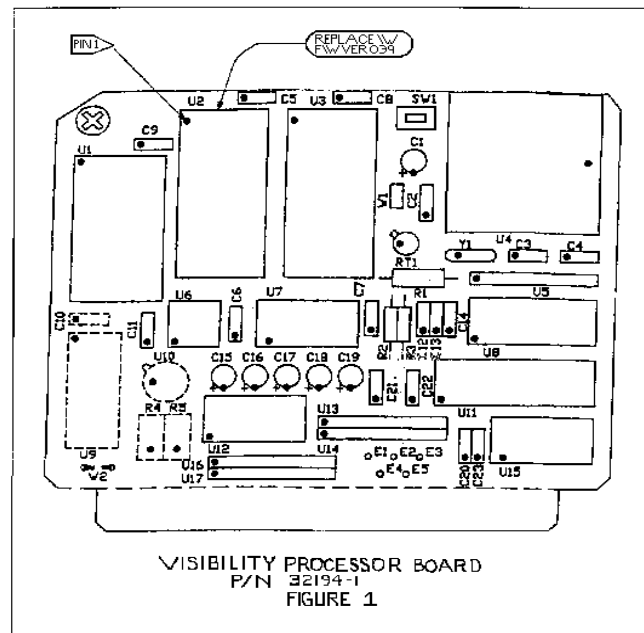
1. At the data collection package (DCP) cabinet, set the visibility sensor circuit breaker module to the **OFF** (right) position.
2. At the sensor, open the visibility sensor electronics enclosure access door and locate the processor board A1A1 (32194-1). Remove the captive screw securing the processor board to the standoff. (This screw is on the bottom side of the board).
3. Carefully remove the processor board by pulling it free from the backplane connector, XA1.
4. Using figure 1, locate microcircuit (or EPROM) U2.

5. Remove the EPROM U2 from the processor board.

6. Install EPROM firmware version 040 onto the processor board and press firmly into the socket.
7. Install and secure the processor board into the backplane connector XA1.
8. Inside the DCP, disconnect the visibility sensor's DB-9 cable connector from the fiber-optic modem on top of the faraday box.
9. Connect the personal computer (PC) to the DB-9 cable connector in the DCP, using the Y-shaped RS232 adapter cable. Turn on the PC, initialize PROCOMM Plus, and press any key to enter the terminal mode. Check to ensure the communication protocol is set to "2400,N,8,1".
10. At the DCP, turn the visibility sensor circuit breaker to the **ON** (left) position.
